ALLEGATIONS OF ENVIRONMENTAL CONTAMINATION AND HAZARDS AFFECTING THE INUPIAT COMMUNITY OF THE ARCTIC SLOPE, ALASKA

Report No. 98-213

September 28, 1998

Office of the Inspector General Department of Defense

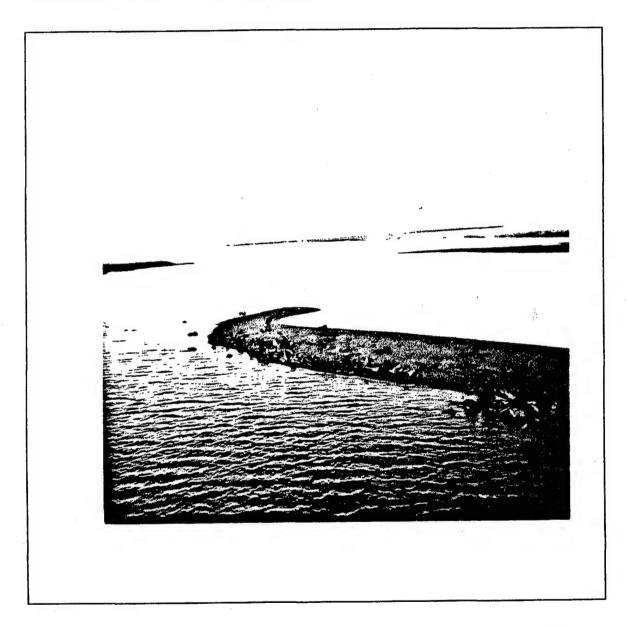
Wainwright. The IG team visited the main Wainwright DEW line site. The team searched the site and did not find any debris. However, while departing the main Wainwright DEW line site in a helicopter, we observed rusted drums close to the southeastern area of the Wainwright DEW line site near Tutollvik. The Air Force project manager was not aware of drum disposal in that area and stated that the Air Force would investigate the newly identified site (see photographs in Appendix G).

We found that the Air Force did not locate drums and debris south of Wainwright DEW line site near Tutollivik (Appendix C). Consequently, the area was not considered for remediation.

A view of drums and debris close to the southeastern area of the Wainwright DEW line site near Tutollvik (Finding A).

A. We recommend that the Deputy Assistant Secretary of the Air Force (Environment, Safety and Occupational Health) resurvey Wainwright and Cape Lisburne DEW line sites; clean up debris at those sites; and clean up any chemical contamination of the environment.*

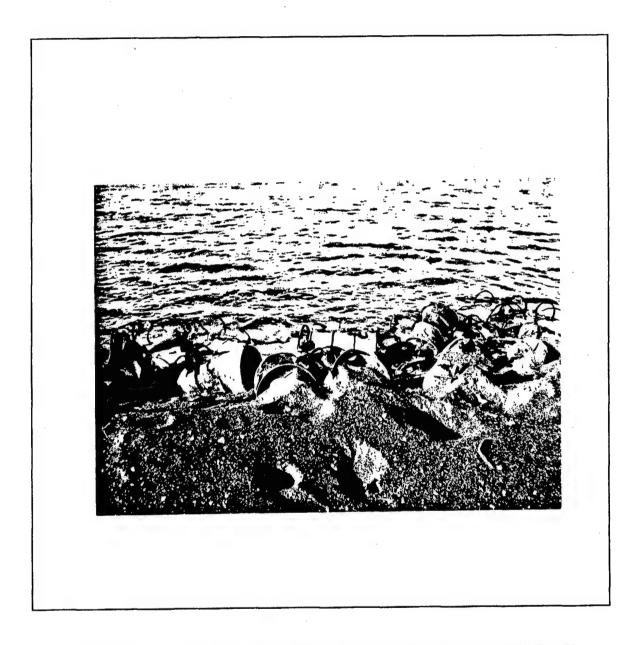
On August 19, 1997, the IG team visited the NARL and observed partially buried drums and debris at the old disposal site. We were unable to determine whether the Ukpeagvik Inupiat Corporation identified those drums in 1988 for removal by the contractor.

A view of drums and debris at the NARL Old Waste Disposal Area (Finding B).

Very badly deteriorated drums were noted at the Old Disposal Site (between Imikpuk Lake and Middle Salt Lagoon) during the survey, but none were proposed for disposal in 1988. The Navy's contractor and UIC's contractor agreed that these drums did not pose a significant safety risk and that removal would cause substantial damage to the tundra. Instead, environmental sampling was done to determine the possibility of contamination migrating from the site.

- B.1. We recommend that the Deputy Assistant Secretary of the Navy clean up drums and debris from the NARL areas.
- B.2. We recommend the Deputy Under Secretary of Defense (Environmental Security) resolve the issue of who is responsible for mitigation of environmental and safety issues involving Elson Lagoon.
